# LEVEL 2 REPLACEMENT RESERVE REPORT FY 2024 WILLOW GLEN ESTATES AT BEAU RIVAGE

## WILLOW GLEN ESTATES AT BEAU RIVAGE

WILMINGTON, NORTH CAROLINA  
November 09, 2023

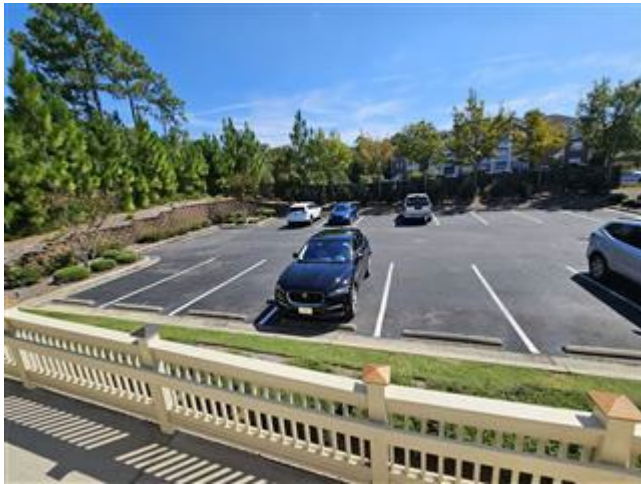
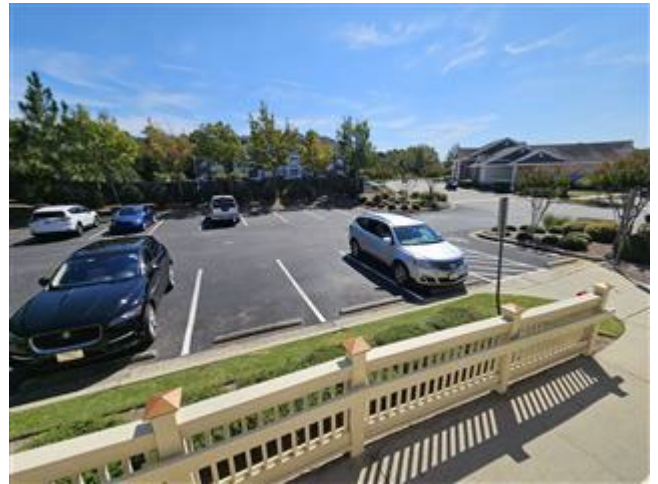
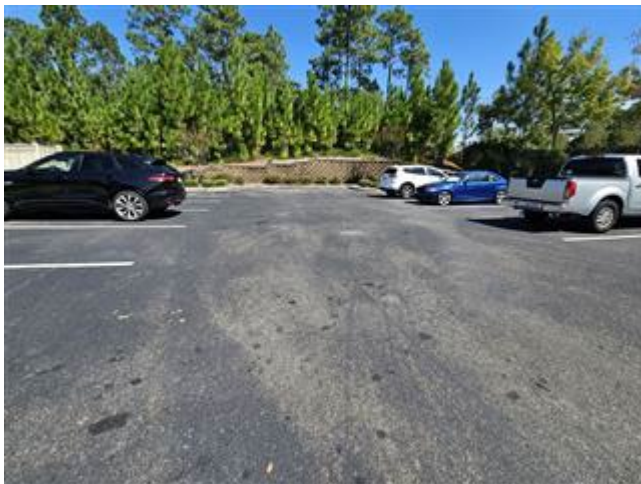
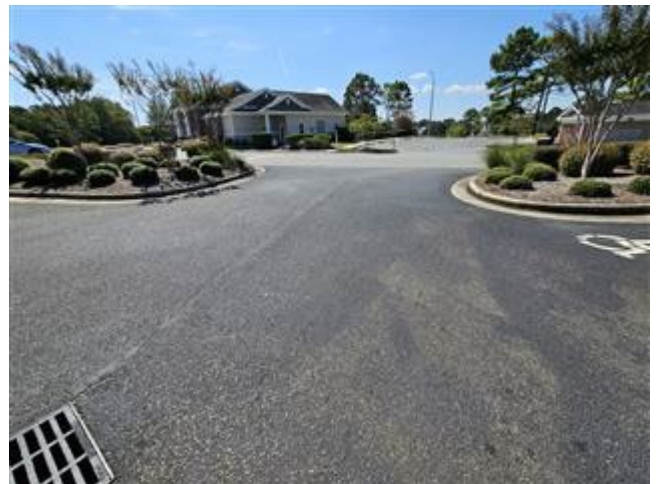
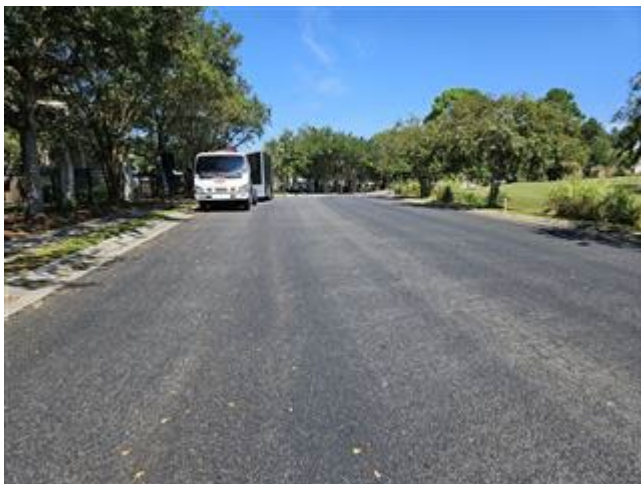
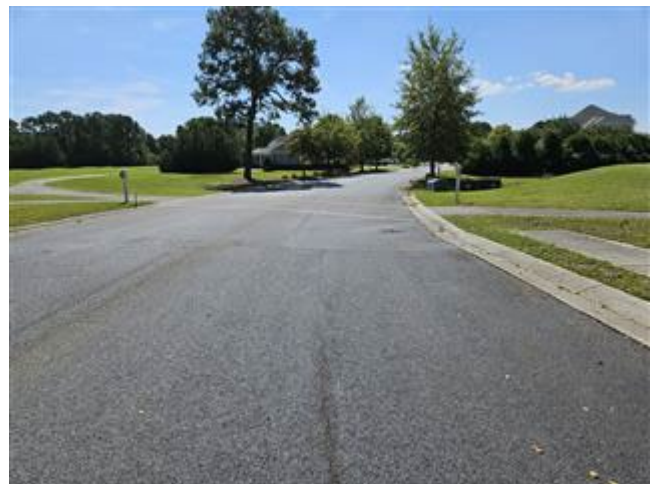
**The Defects noted include the following:**

- **Open Cracks.** There is one large crack in the pool area parking lot, that will allow water to penetrate the asphalt base and the bearing soils beneath. This crack should be repaired. Over time, water will erode the base and accelerate the deterioration of the asphalt pavement. If cracks extend to the base and bearing materials, remove the damaged areas and replace defective materials. As a part of normal maintenance, clean and fill all other cracks.

As a rule of thumb, asphalt should be overlaid when approximately 5% of the surface area is cracked or otherwise deteriorated. The normal service life of asphalt pavement is typically 18 to 20 years.

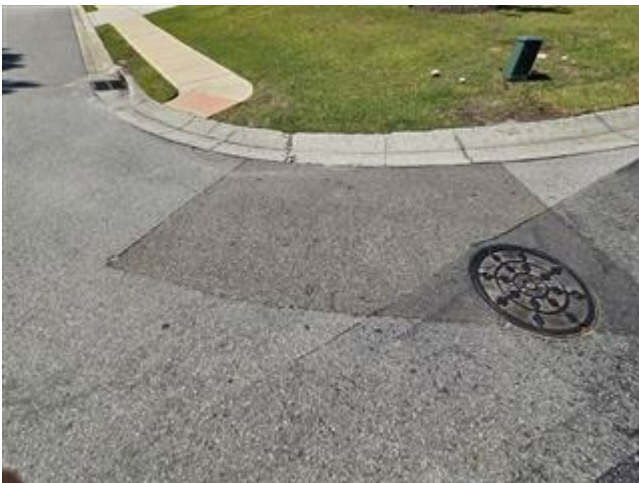
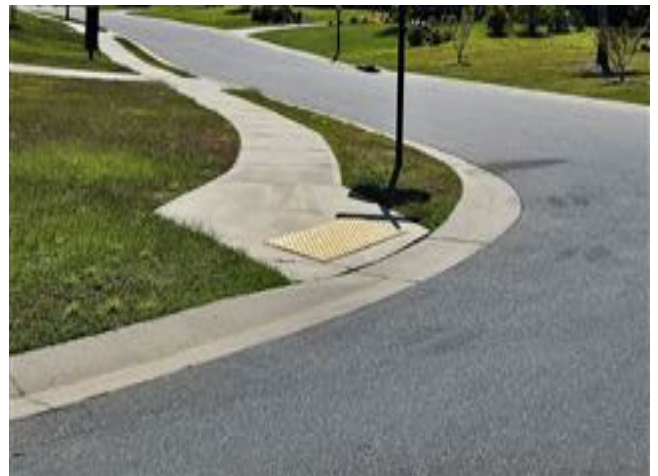
**Concrete Work.** The concrete work includes the community sidewalks, curbs, and gutter as well as other flatwork. We have modeled for curb replacement to be done incrementally, where needed, approximately every 6 years. The overall condition of the concrete work appears to be in good, with no trip hazards noted.

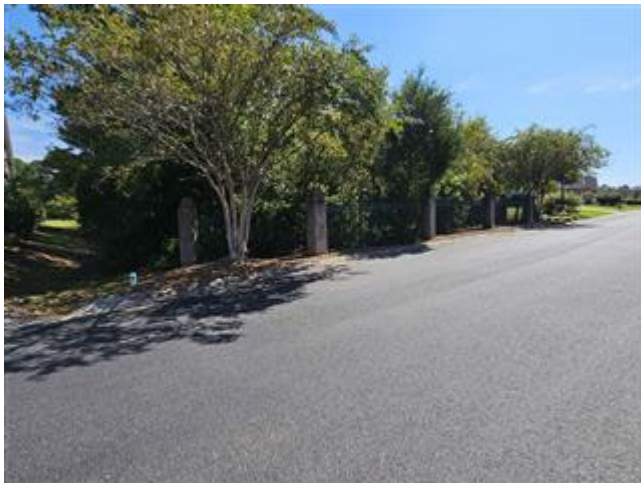
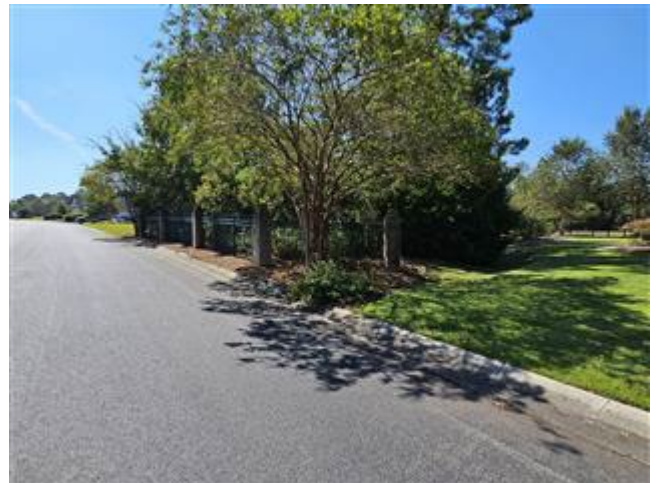
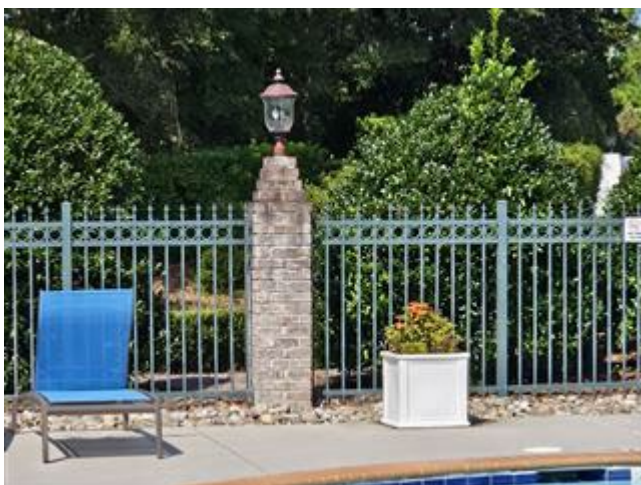
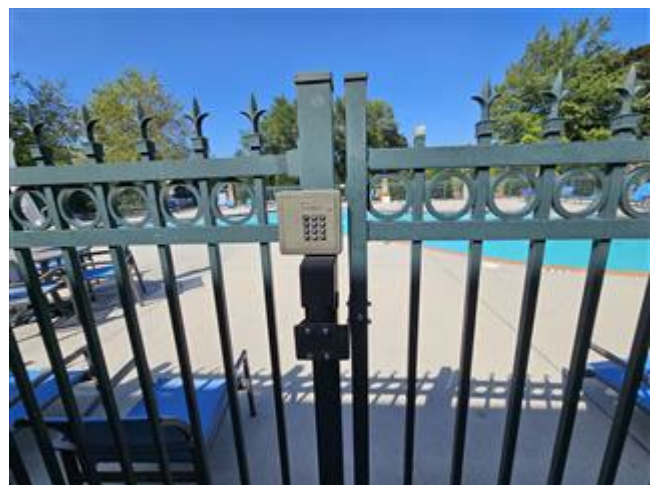
**Fencing.** The Association maintains decorative aluminum fencing at the gateway to the community and at the swimming pool area, all of which appear to be in good condition. Fencing systems have a large number of configurations and finishes that can usually be repaired as a maintenance activity by replacing individual components as they become damaged or weathered.

Protection from string machine damage during lawn maintenance can extend the useful life of some fence types. Protection from this type of damage is typically provided by applying herbicides around post bases or installing protective sheathing.

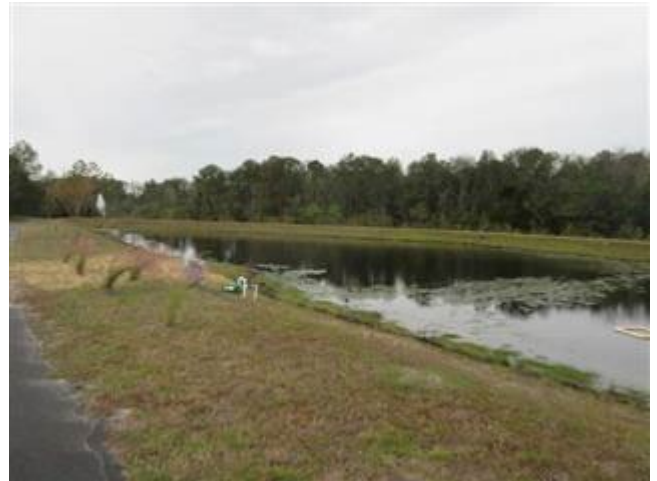
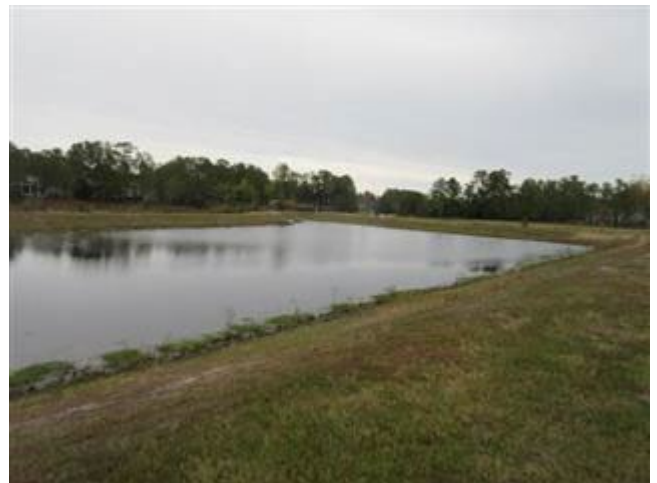
**Stormwater Pond.** The community is served by a stormwater pond, which appears to be in good condition. It is not possible to accurately estimate dredging volume in a body of water without the data provided by a detailed Bathymetric Study. MillerDodson Associates recommends that the Association arrange through their Pond and Lake specialist to have Bathymetric Studies conducted. At that time, the Reserve Study can be revised to reflect the data provided by the Bathymetric Study.

As a rule of thumb, dredging should be performed when approximately one-third of the volume of the pond has been filled with silt. In the absence of accurate information about the original depth of the pond and the local siltation rate, we have assumed that it will be necessary to remove one cubic yard of material over a third of the pond area periodically as noted in the inventory. We have assumed that the material being removed is free of heavy metals and hydrocarbons and that it will be accepted as fill at a local landfill. A more accurate prediction of cost and cycles will require a hydrologic analysis and testing, which is beyond the scope of our study.

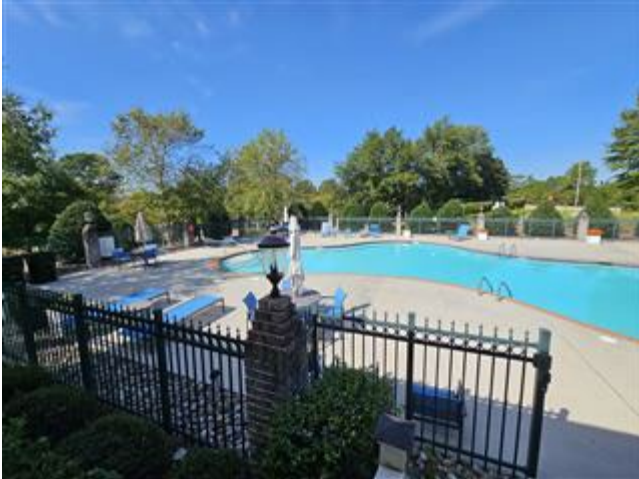
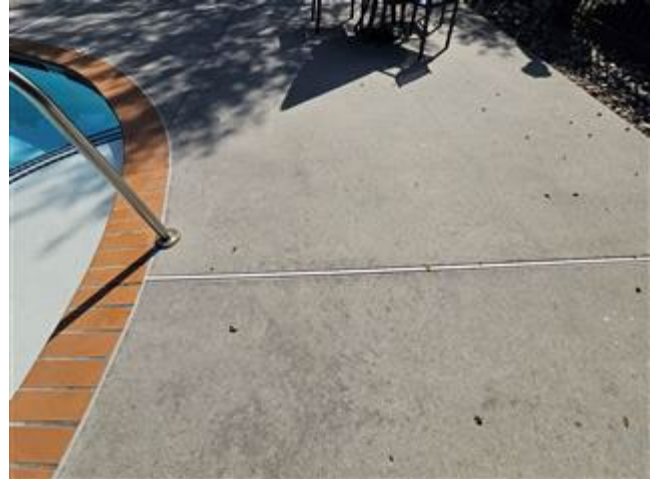
Pool Shell. The shell for the swimming pool appears to be in good condition.

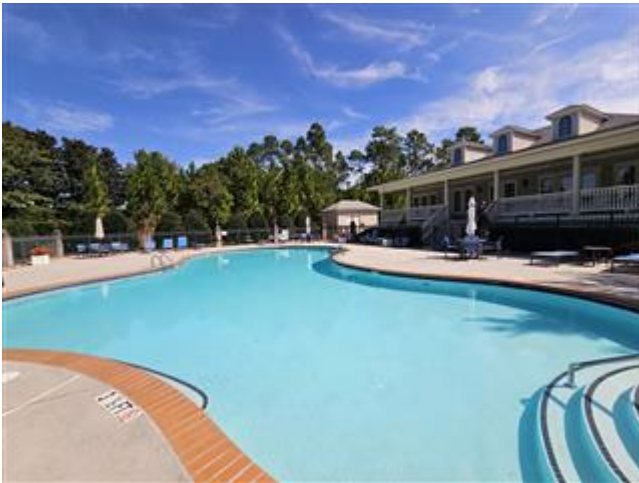
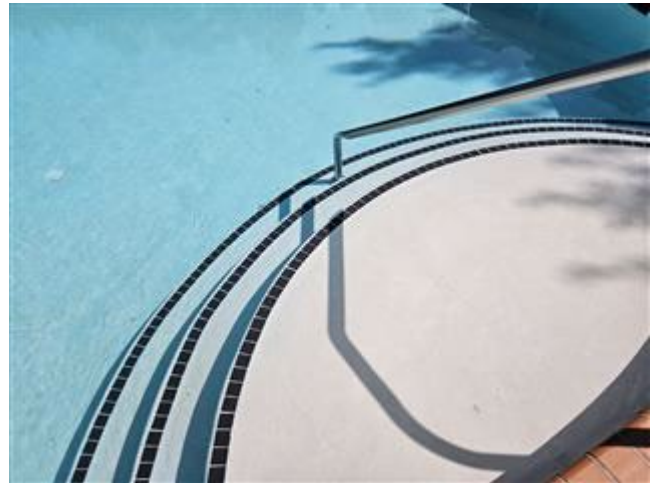
Pool Deck. The pool has a concrete deck, and the overall condition of the deck appears to be in good condition with no tripping hazards.

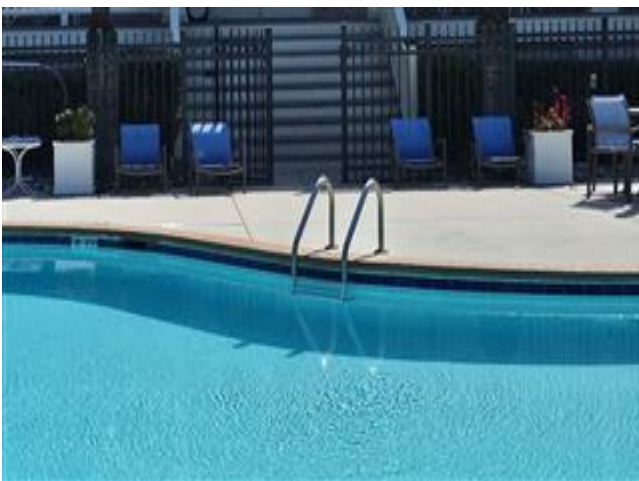
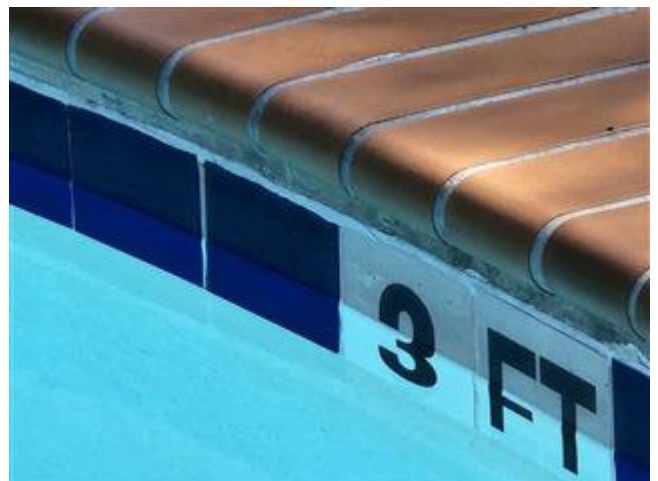
Whitecoat. The pool whitecoat appears to be in fair condition. We have assumed a service life of ten years for the pool whitecoat. The Association plans to redo the whitecoat, so it will be new for 2024.

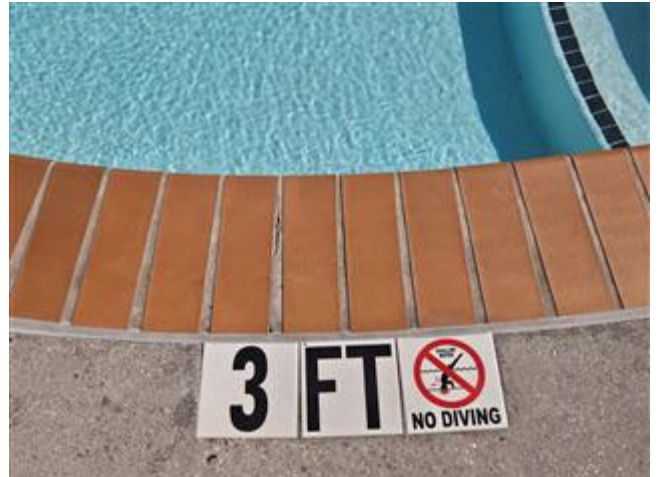
Waterline Tile. The waterline tile appears to be in good condition. We have assumed the waterline tile will be replaced or restored when the pool is whitecoated.

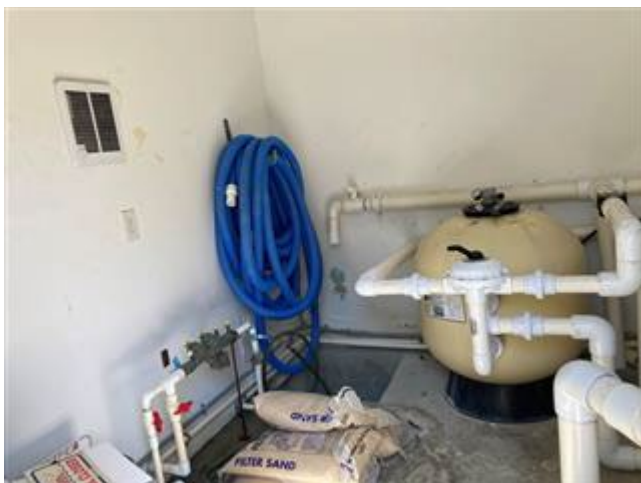
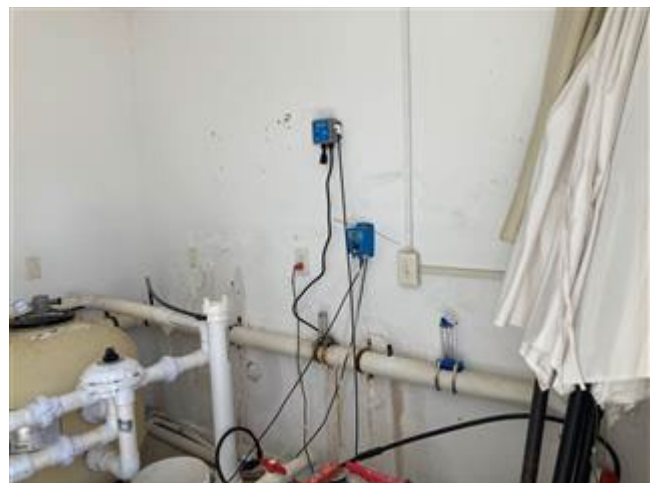
Pump and Filter System. The filter system is reported to be in good operating condition.

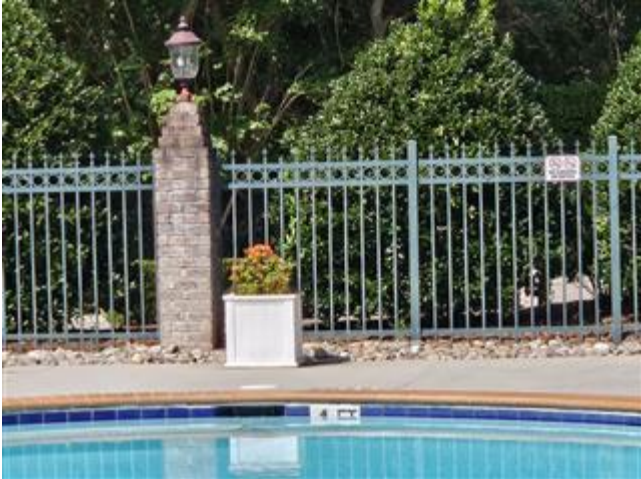
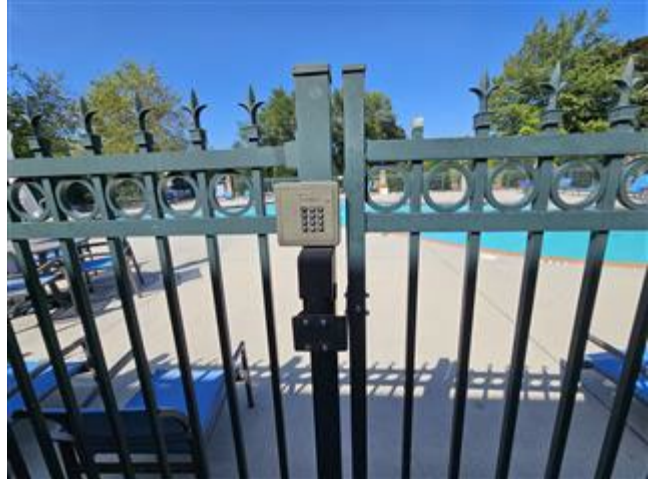
Pool Fence. The swimming pool is enclosed by a metal fence that appears to be in good condition.

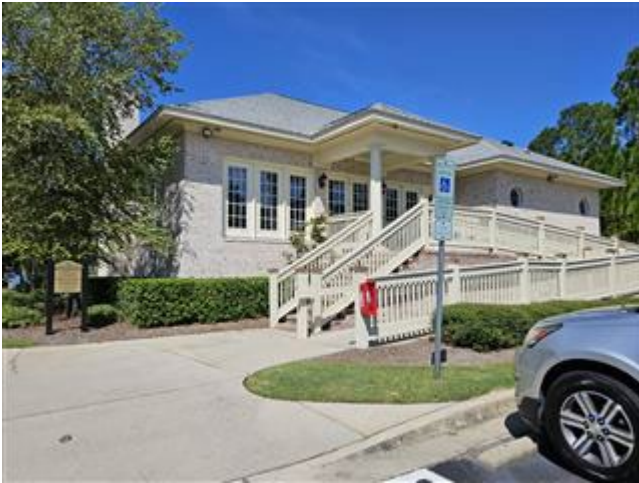
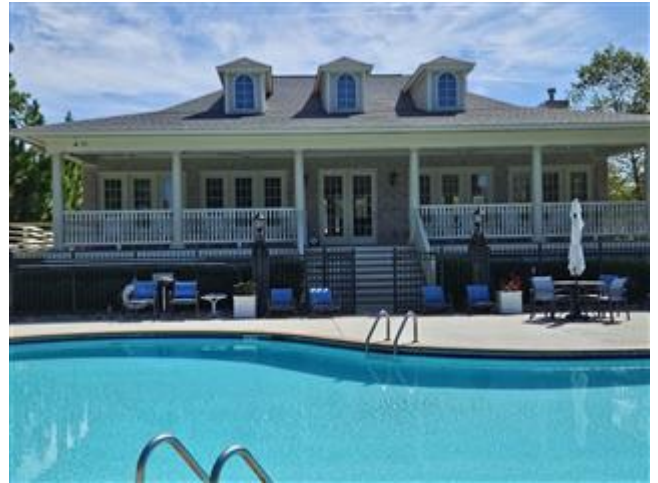
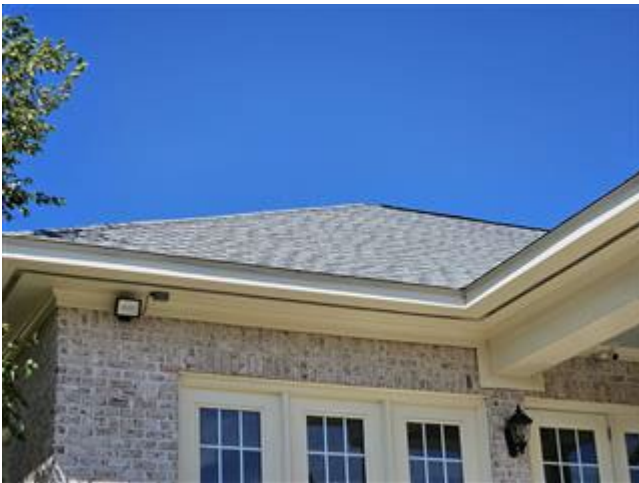
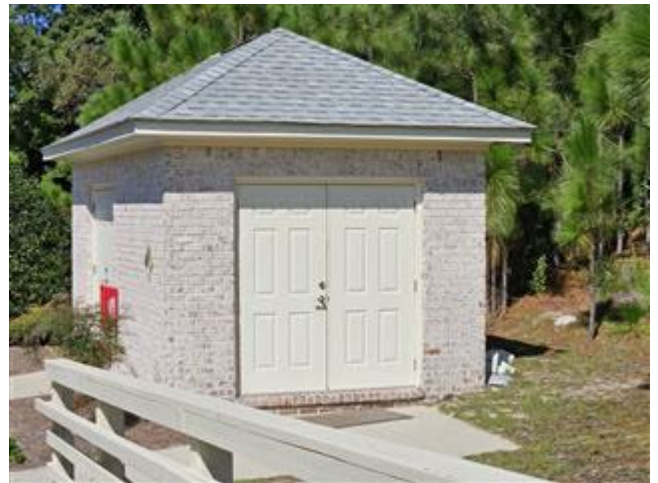
**Building Roofing.** The clubhouse and pump house have asphalt shingle roofs that appear to be in very good condition.

Annual inspections are recommended, with cleaning, repair, and mitigation of vegetation performed as needed. Access, inspection, and repair work should be performed by contractors and personnel with the appropriate access equipment who are experienced in the types of roofing used for the facility.

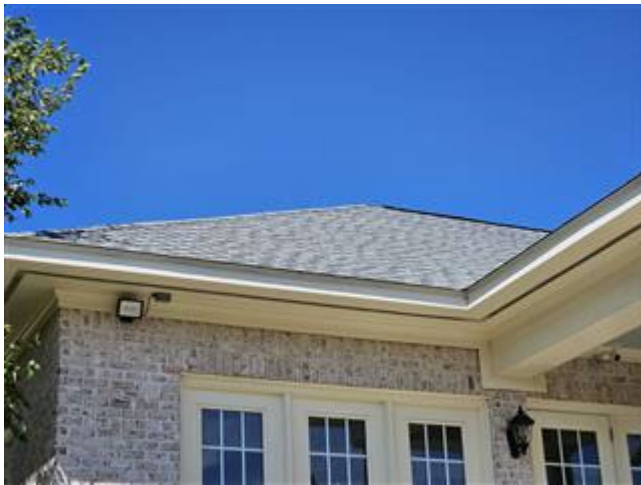
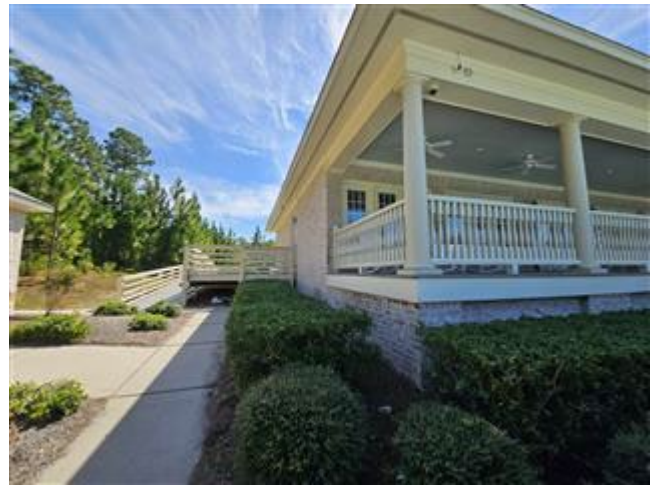
**Siding and Trim.** The exterior trim on the clubhouse and pump house appears to be in good condition.

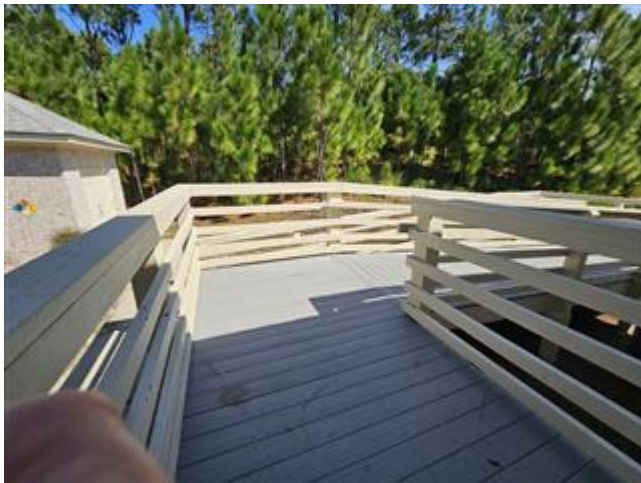
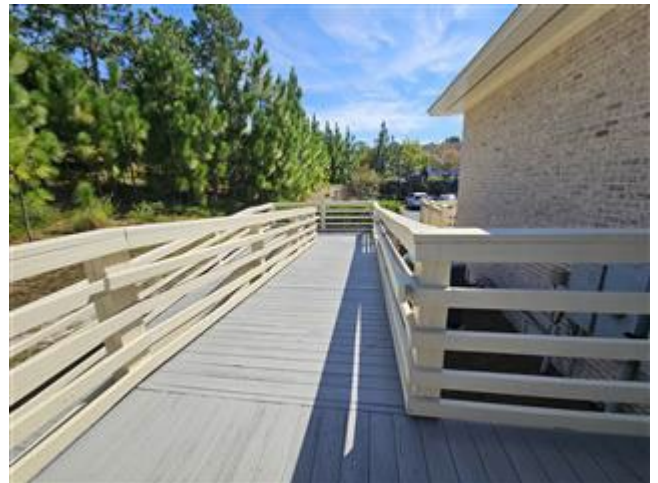
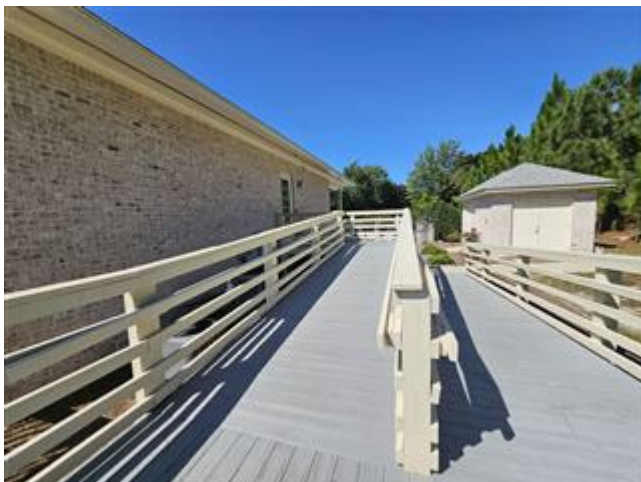
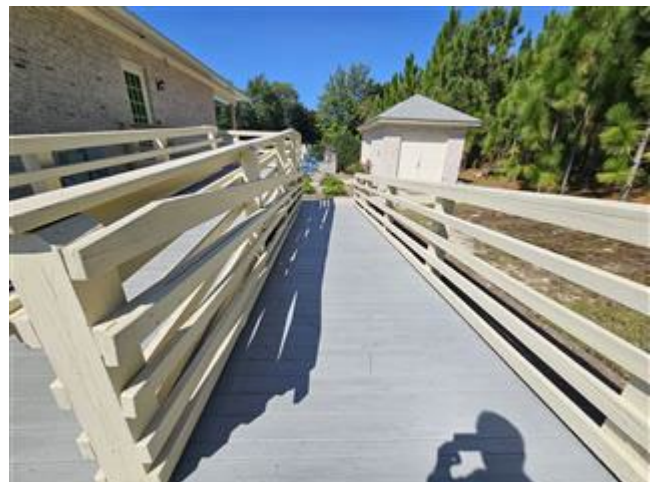
**Exterior Wood Stairs and Handicapped Ramp and Deck** The exterior handicapped ramp consists of pressure treated wood. The ramp appears to be in good condition. There is light deterioration of the ramp decking and side rails.

The wood in the handicapped ramp expands and contracts with changes in temperature and moisture levels within the wood, leading to cracks. Untreated, these cracks will expand and can lead to the development of rot within the wood.

It is recommended that the Association inspect all stairs at least once each year. All areas with moderate cracking or rot should be replaced. Areas covered with mold should be cleaned and treated. The structure and decking have been separated into two components because they have different expected useful life.

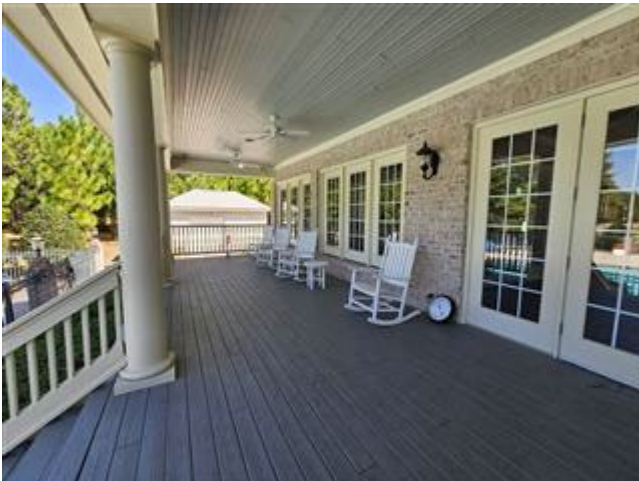
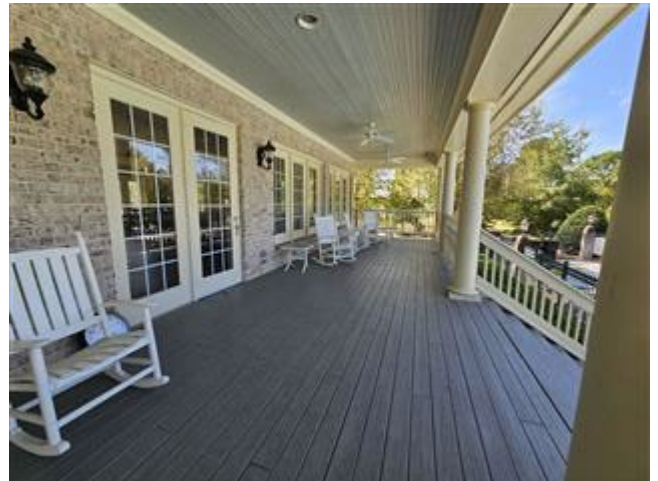
**Decks/Balconies.** The Association maintains a deck at the community club house. The deck structure appears to be in good condition, with the composite decking appearing to be in good condition as well. The wood railing system appears to be in good condition.

We recommend that the Association implement an annual inspection and power-washing program. Installation of carpet or other water-trapping coverings should be prohibited, and potted plants should be placed on raised feet to allow for proper air circulation and drying.

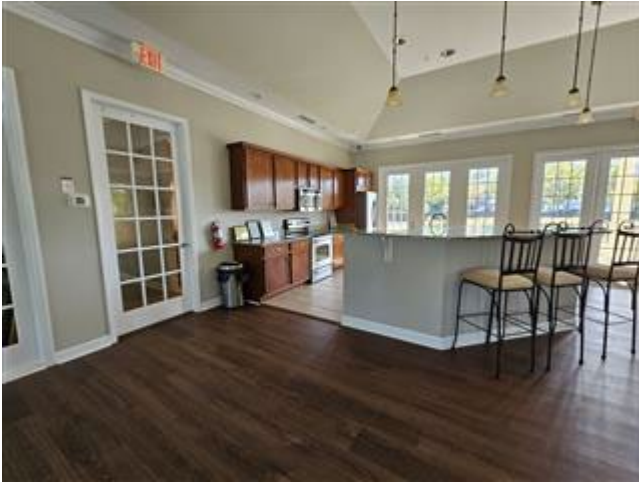
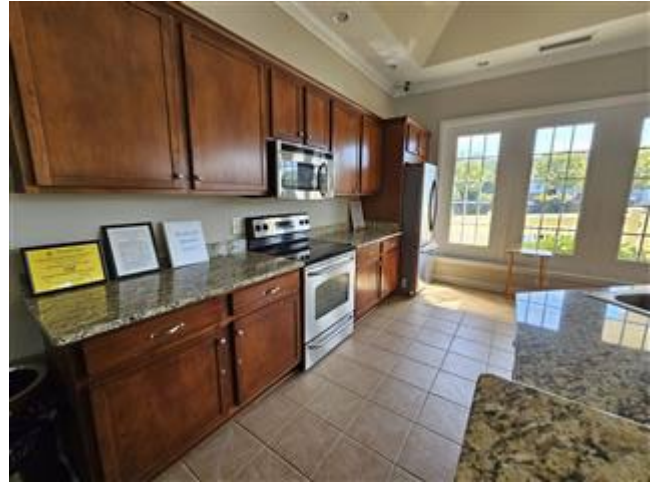
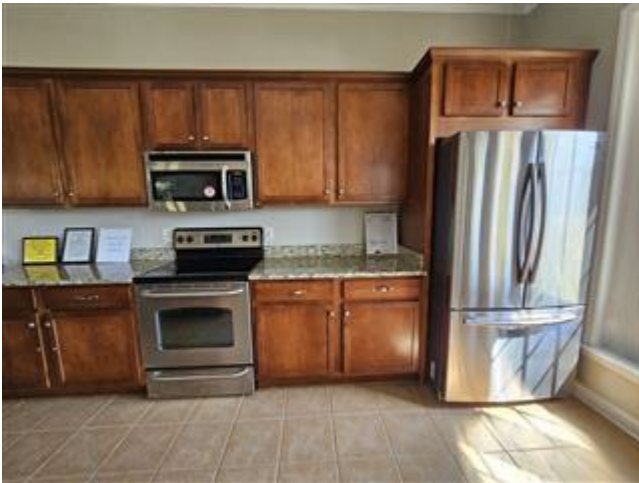
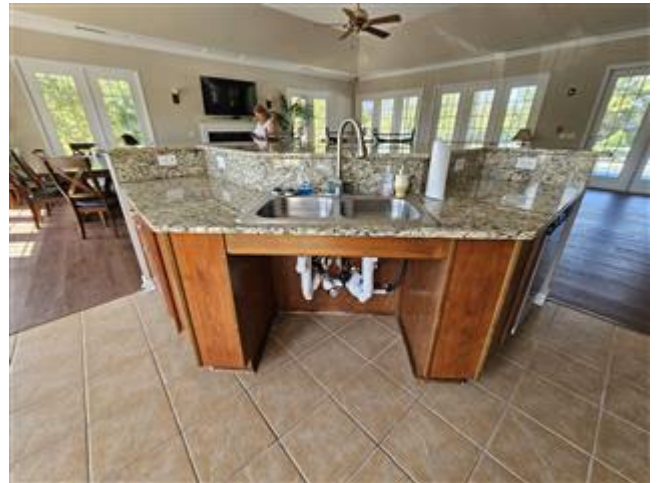
**Kitchen.** There is a kitchen in the clubhouse, which is comprised of cabinetry, granite countertops, a range, a double bowl sink, a dishwasher, a refrigerator, with an icemaker, a microwave, a coffee maker, and miscellaneous kitchen utensils. The flooring is ceramic tile. All of the furnishings and equipment in the kitchen appear to be in good condition.

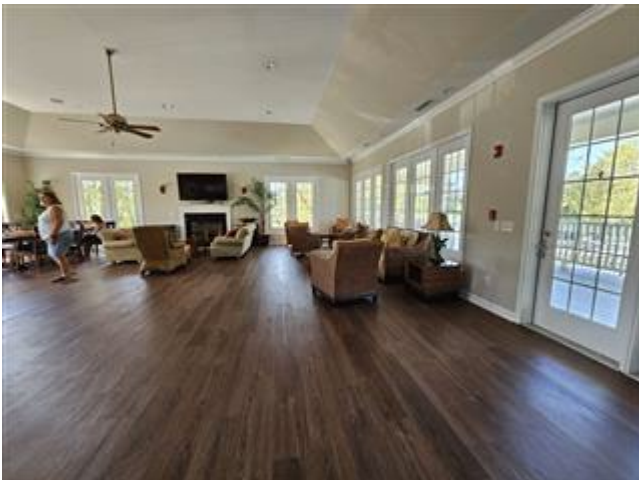
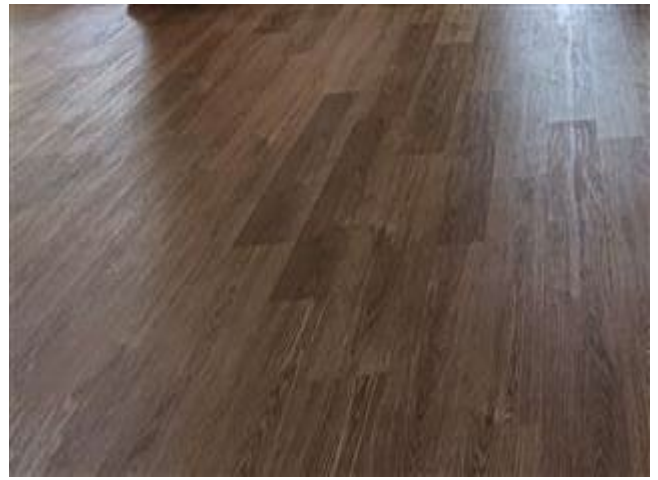
**Luxury Vinyl Flooring.** The multipurpose rooms have luxury vinyl flooring. The flooring was installed in 2022 and appears to be in good condition.
