# LEVEL 2 REPLACEMENT RESERVE REPORT FY 2024 WILLOW GLEN ESTATES AT BEAU RIVAGE

## WILLOW GLEN ESTATES AT BEAU RIVAGE

WILMINGTON, NORTH CAROLINA  
November 09, 2023

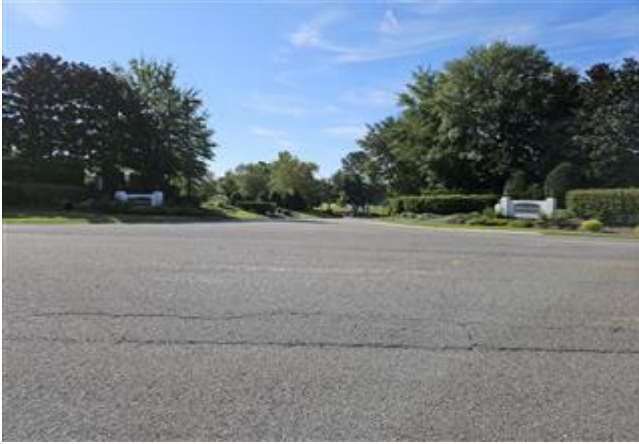
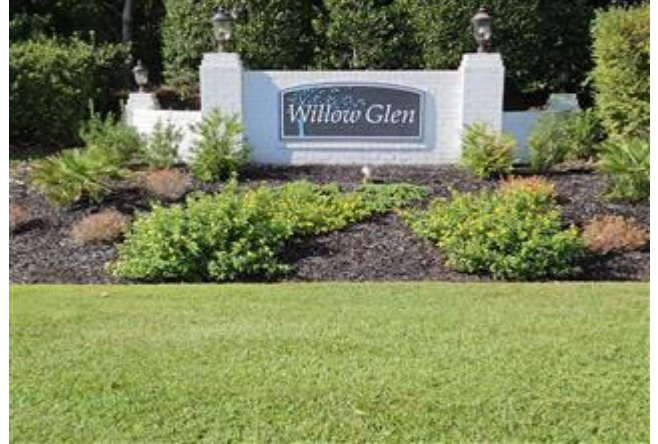
**Entry Monument and Signage.** The Association maintains two monuments, which are made of masonry and which have a carved wood sign mounted to the masonry. They appear to be in good condition. To keep the monument fresh and appealing, we recommend the replacement of the carved wood signs every 10 to 15 years.

We recommend re-pointing and replacement of defective areas of the masonry as needed. The Association may want to consider applying a coating of Siloxane or other appropriate breathable sealants to mitigate water penetration and further degradation of the masonry work. The monument masonry is painted, which helps to seal the masonry.

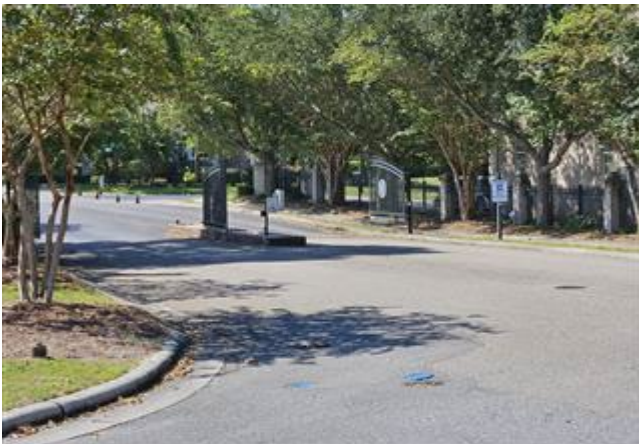
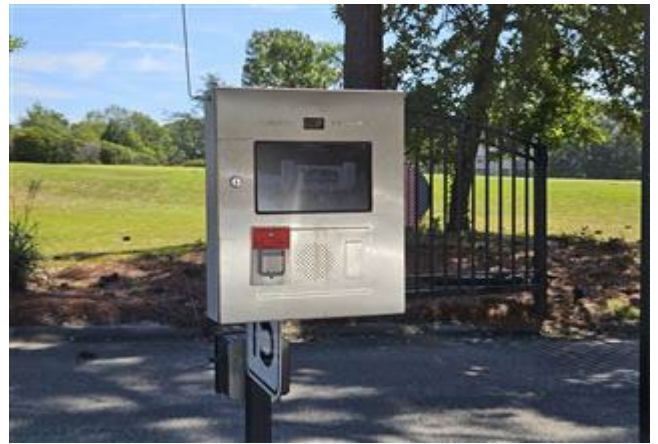
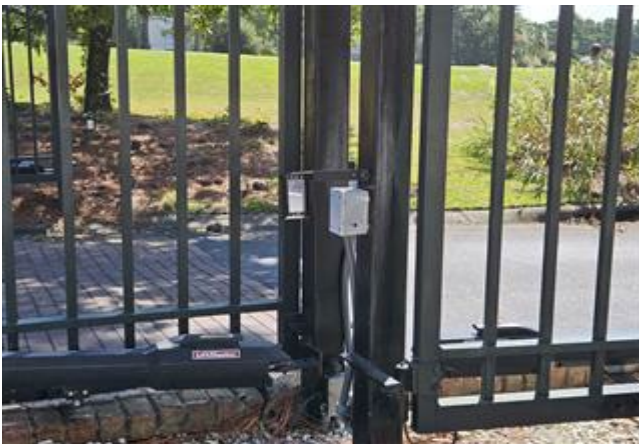
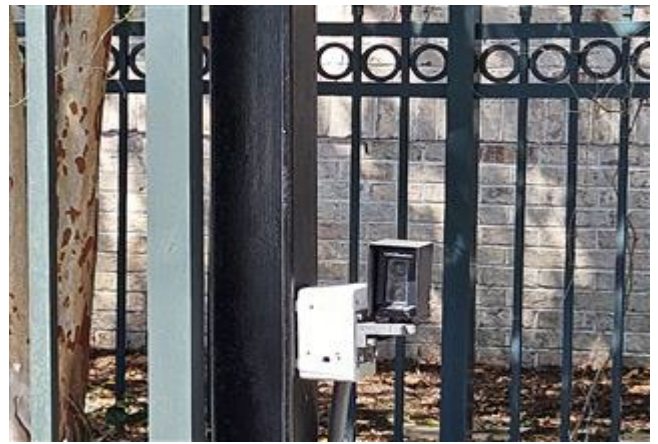
**Vehicle Access System.** Perimeter access control is established via electronic access control and vehicle access gates. The entry gate was set in an open position at the time of the site visit, but it was reported systems are in good condition and operating normally.

- Readers. Maintain all connections and security interfaces.
- Gates. Maintain hinges and fence sections. Keep the swing or slide area clear of debris and obstructions.
- Actuators. Inspect actuators periodically to ensure proper function.
- Electrical. Maintain boxes, connections, and conduits to keep out water and moisture.

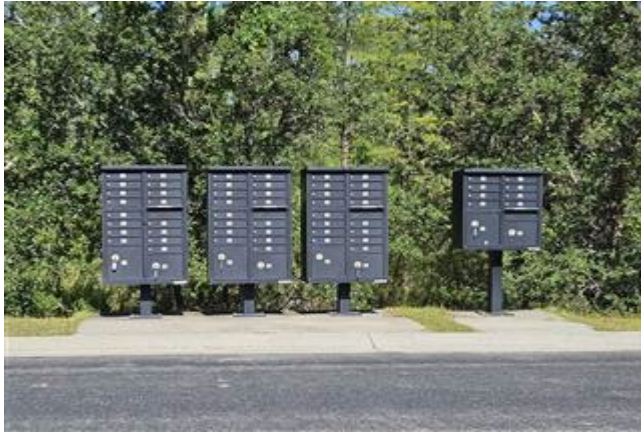
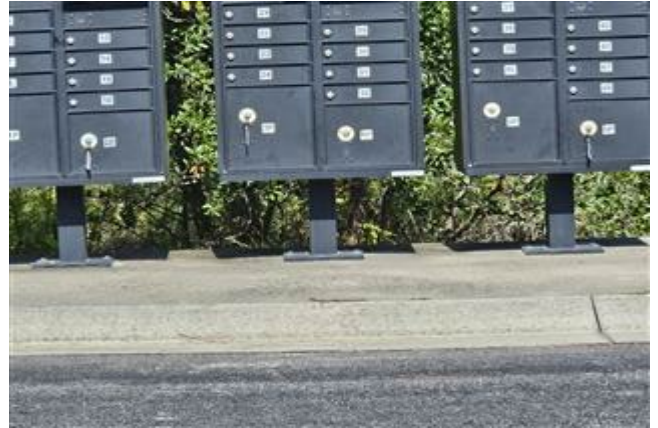
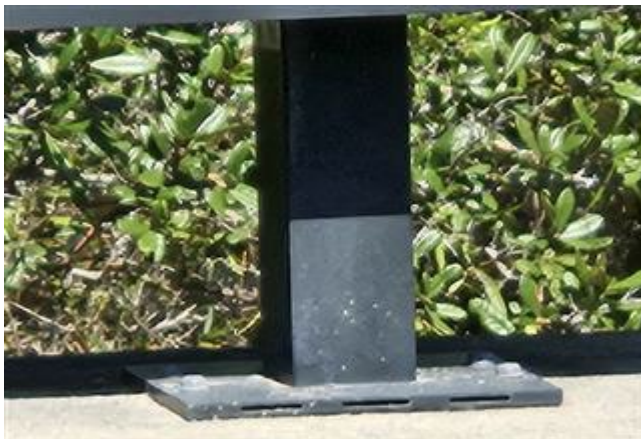
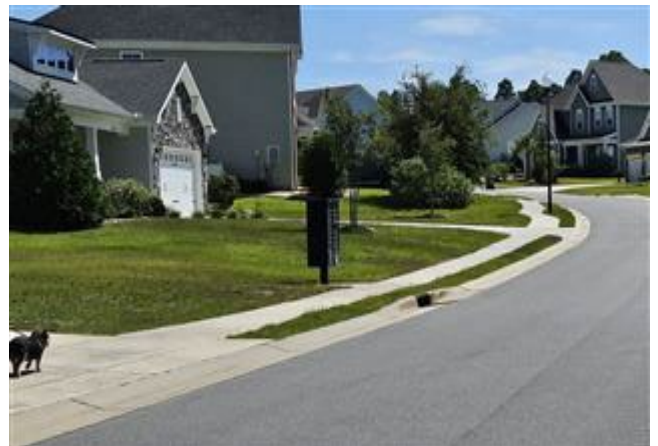
**Mailboxes.** Pedestal mailboxes are located throughout the community, All of the mailboxes appear to be in good condition.

Mailboxes should be maintained to the extent that rust does not develop on the structure or pedestal, and all mail slot doors remain intact with operable hinges and locks. Our replacement estimate assumes that these units will be replaced with fiberglass or composite units in the future.

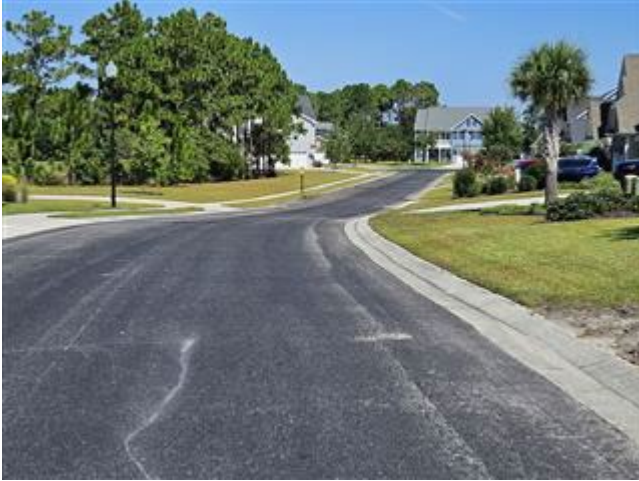
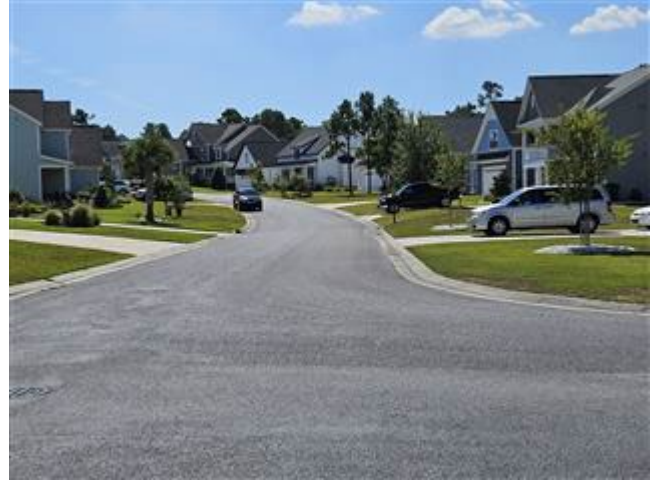
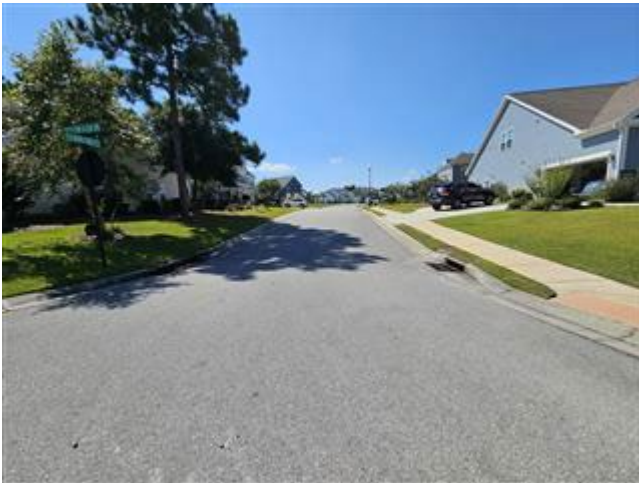
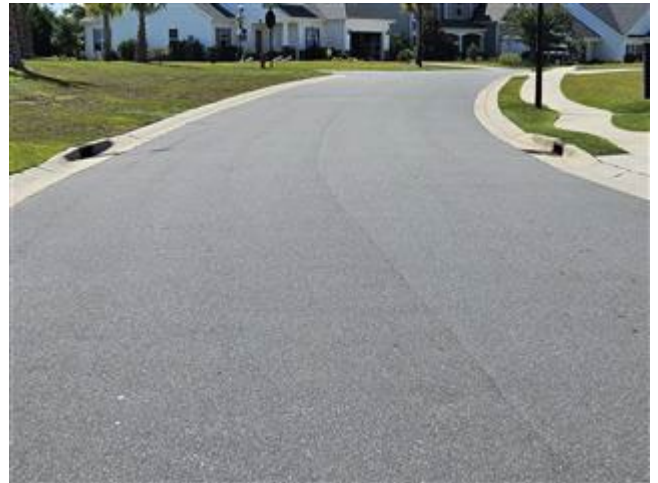
**Asphalt Pavement.** The Association is responsible for the roadways and parking areas within the community. Alleyways are not the responsibility of the Association. The City, County, or other municipality maintains other roadways. In general, the Association's asphalt pavements appear to be in good condition.

To maintain the condition of the pavement throughout the community and ensure the longest life of the asphalt, we recommend the Association adopts a systematic and comprehensive maintenance program that includes:

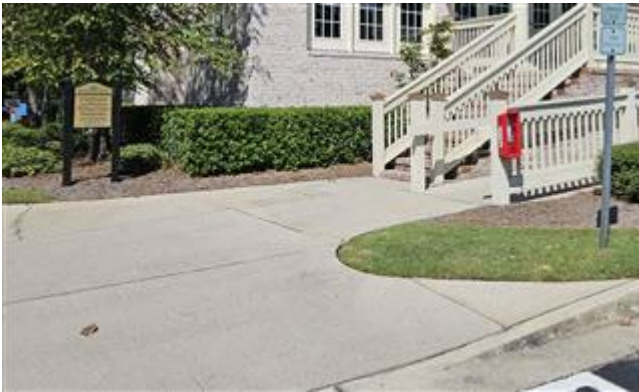
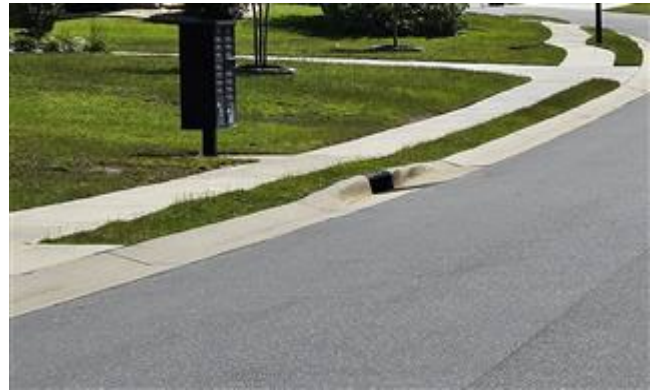
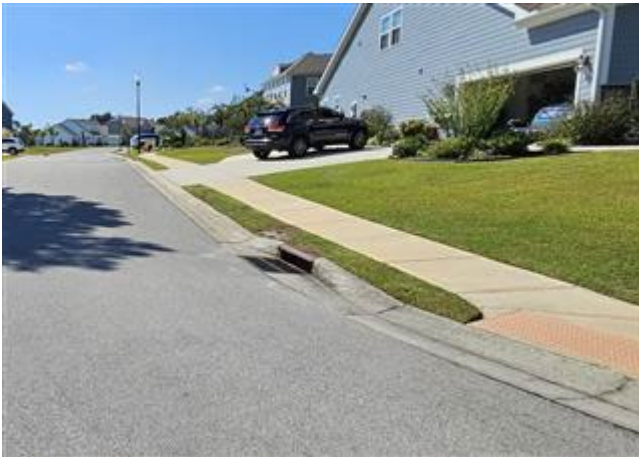
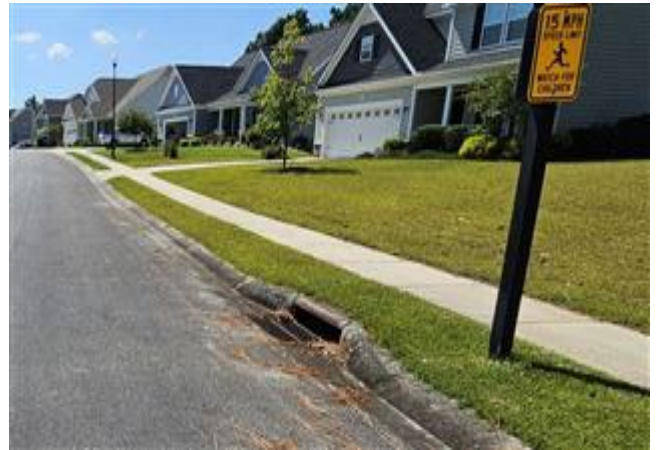
**Concrete Work.** The concrete work includes the community sidewalks, curbs, and gutter as well as other flatwork. We have modeled for curb replacement to be done incrementally, where needed, approximately every 6 years. The overall condition of the concrete work appears to be in good, with no trip hazards noted.

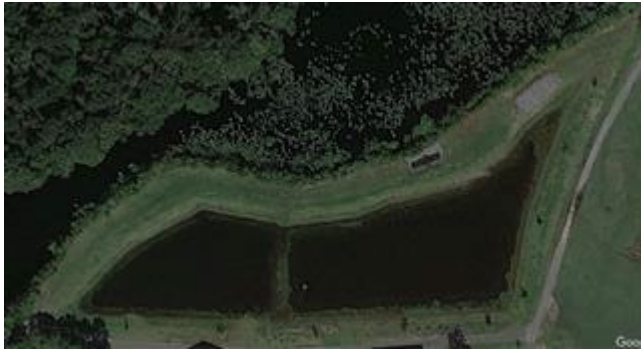
**Stormwater Pond.** The community is served by a stormwater pond, which appears to be in good condition. It is not possible to accurately estimate dredging volume in a body of water without the data provided by a detailed Bathymetric Study. MillerDodson Associates recommends that the Association arrange through their Pond and Lake specialist to have Bathymetric Studies conducted. At that time, the Reserve Study can be revised to reflect the data provided by the Bathymetric Study.

Ponds will accumulate silt over time and lose the ability to store stormwater at design levels, which could result in overflows and minor local flooding. In addition, water quality can be negatively affected by increased siltation and debris accumulation. Accordingly, ponds require periodic dredging.

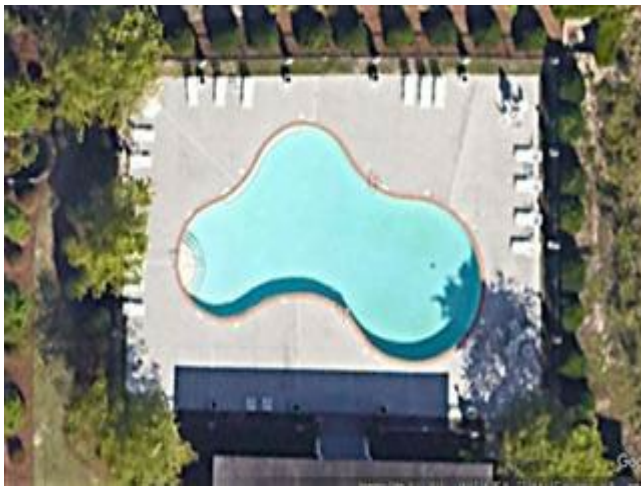
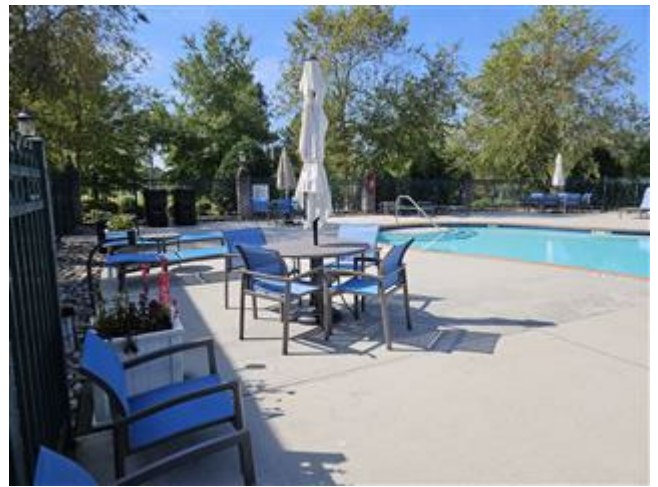
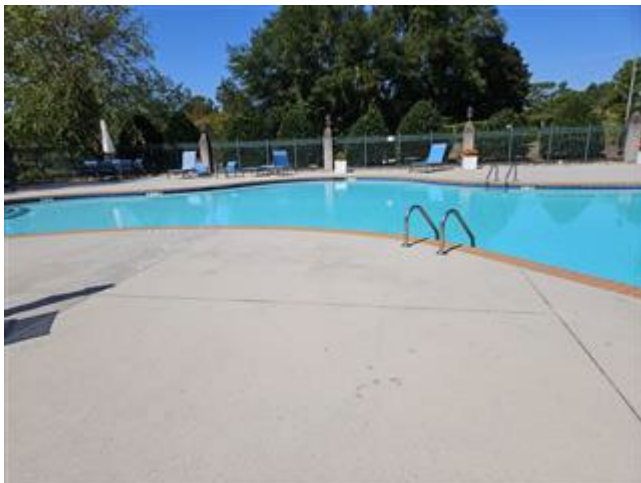
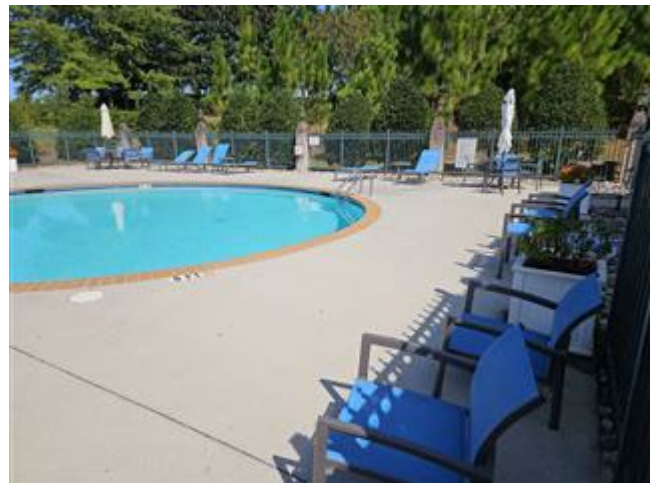
Pool Shell. The shell for the swimming pool appears to be in good condition.

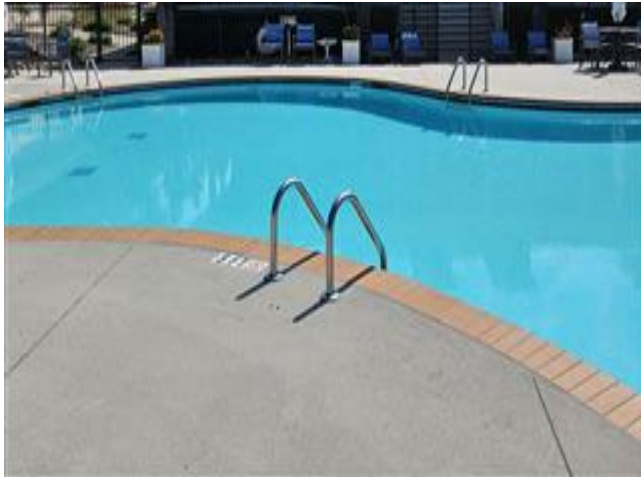
Waterline Tile. The waterline tile appears to be in good condition. We have assumed the waterline tile will be replaced or restored when the pool is whitecoated.

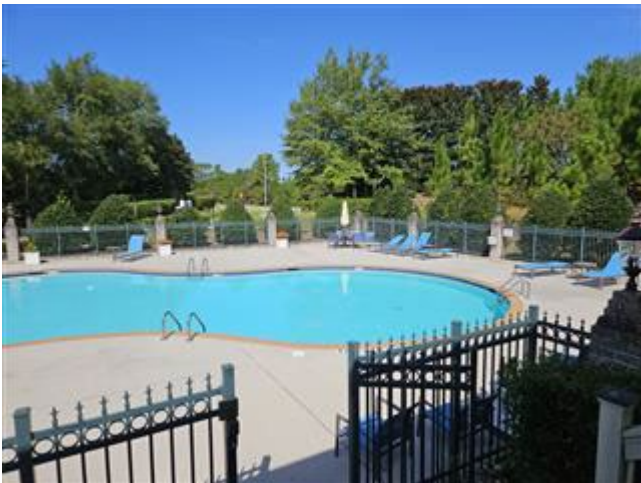
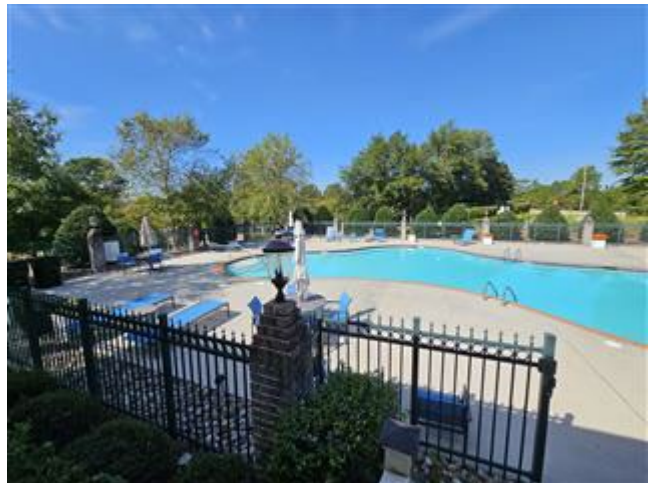
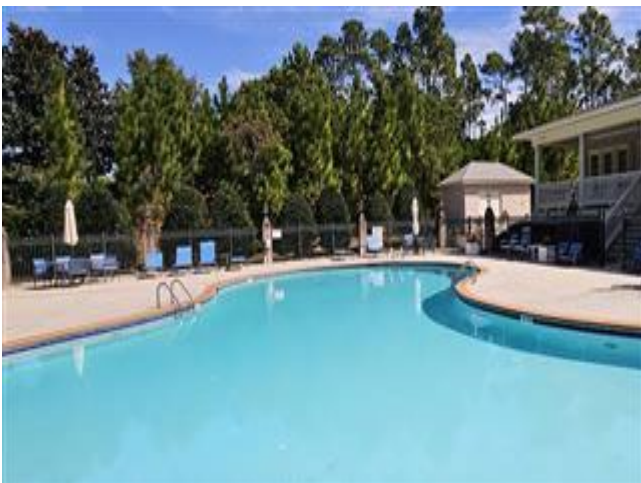
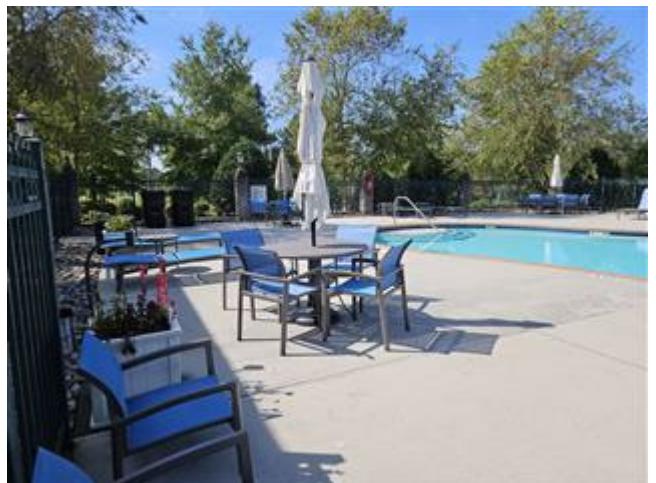
**Swimming Pool Furniture.** We have included the swimming pool furniture in the reserve analysis as a per-item basis because not all of the furniture will be replaced at the same time. The furniture is in good condition. Furniture of this type in this location has a service life of 10 years.

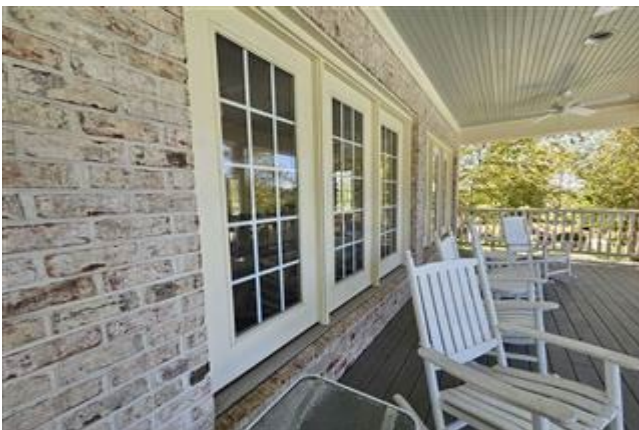
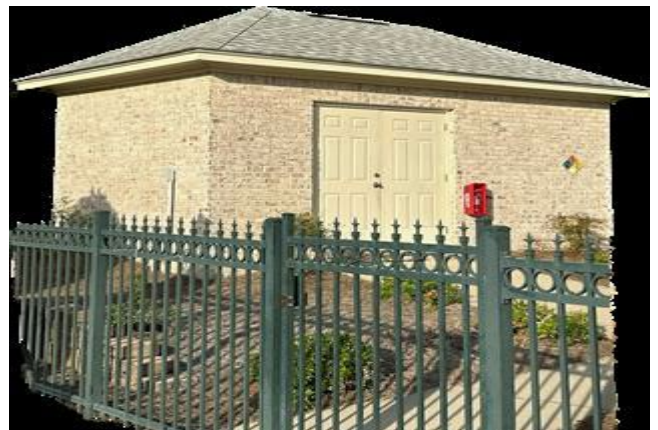
**Masonry.** The clubhouse and pool house are constructed of brick masonry, which appears to be in good condition.

Brick masonry is used as the main exterior cladding of the building. As masonry weathers, the mortar joints will become damaged by water penetration. As additional water gains access to the joints, repeated freeze-thaw cycles gradually increase the damage to the mortar joints. If allowed to progress, even the masonry units such as brick can have their surfaces affected and masonry units can become loose.

In general, masonry is considered a long-life item and is therefore excluded from reserve funding. However, because weather and other conditions result in the slow deterioration of the mortar in masonry joints, we have included funding in this study for repointing. Repointing is the process of raking and cutting out damaged sections of mortar and replacing them with new mortar.

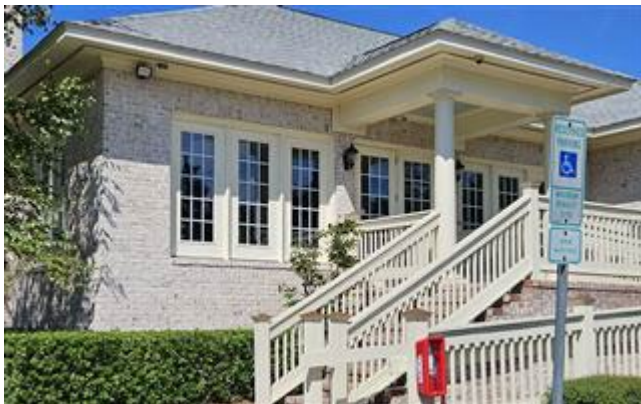
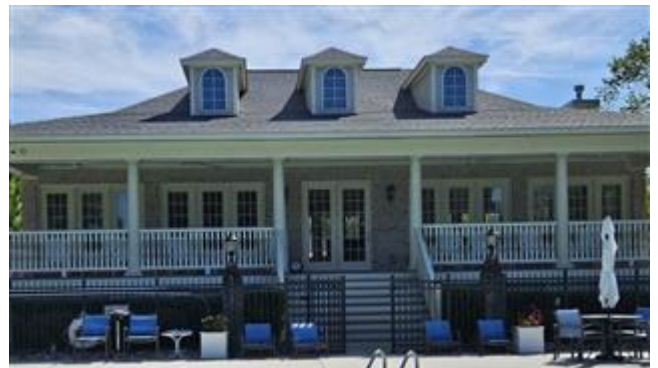
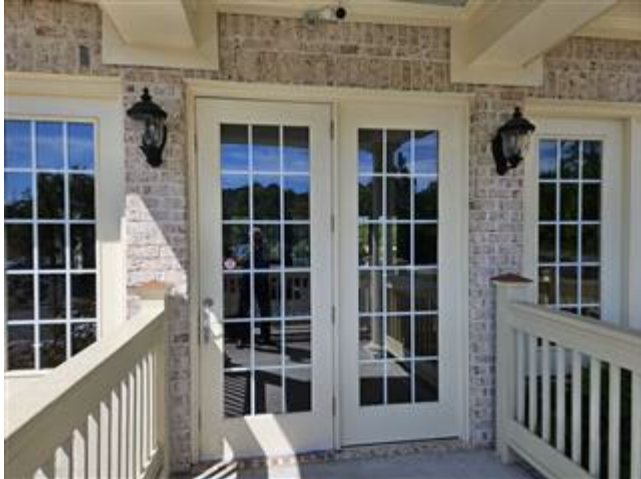
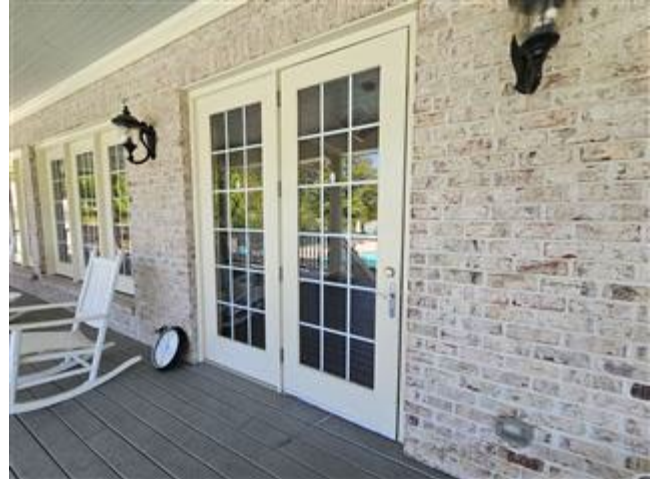
**Windows and Doors.** The Association is responsible for the common windows and exterior doors of the facility and the individual owners are responsible for the windows and doors attributed to their unit.

The windows and doors appear to be in generally good condition.

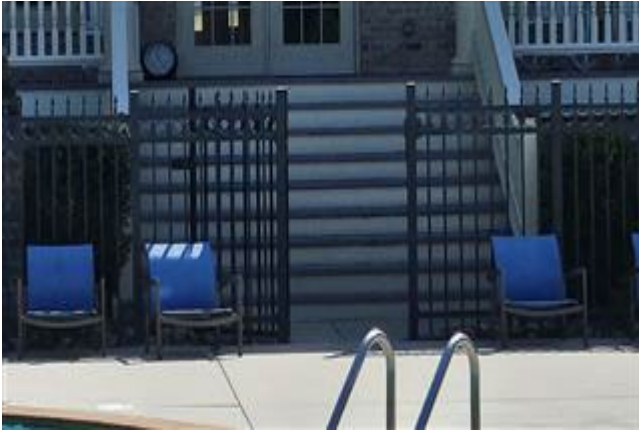
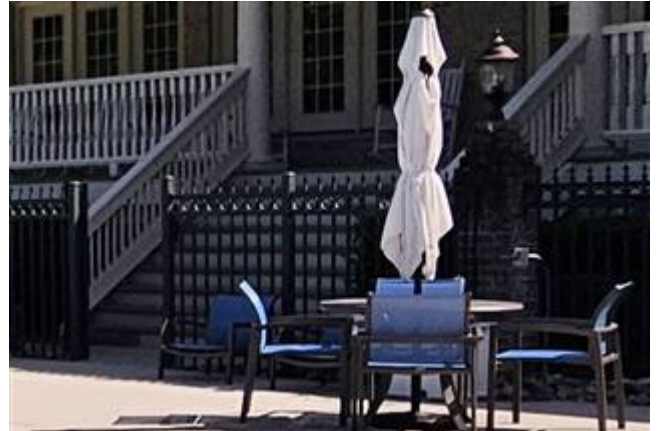
**Pressure Treated Wood/Composite Material Stair.** The rear exterior stair structure is made of pressure treated wood and the treads are constructed of composite material. The general condition of the steps appears to be good, with no defects.

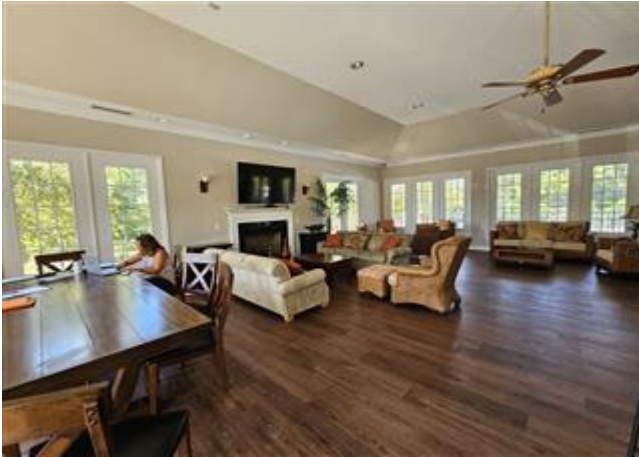
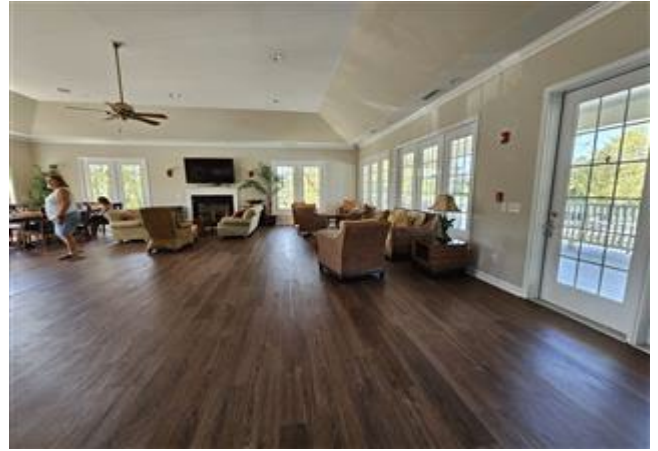
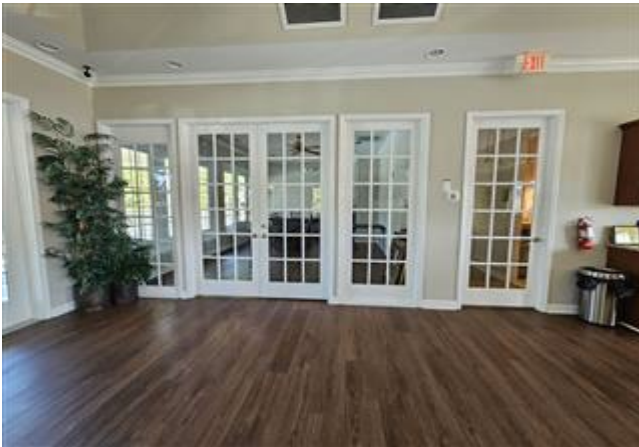
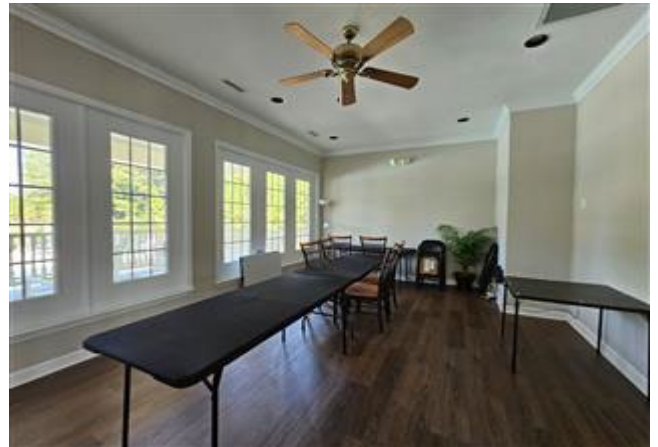
**Common Interiors.** The Association maintains multipurpose rooms, kitchen, restrooms, and other common interior spaces that appear to be in generally good condition.

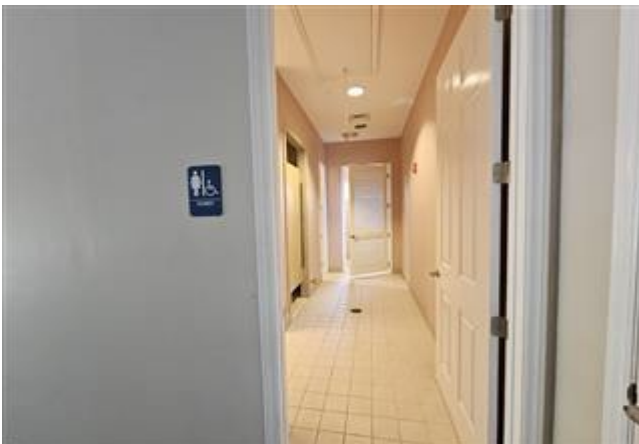
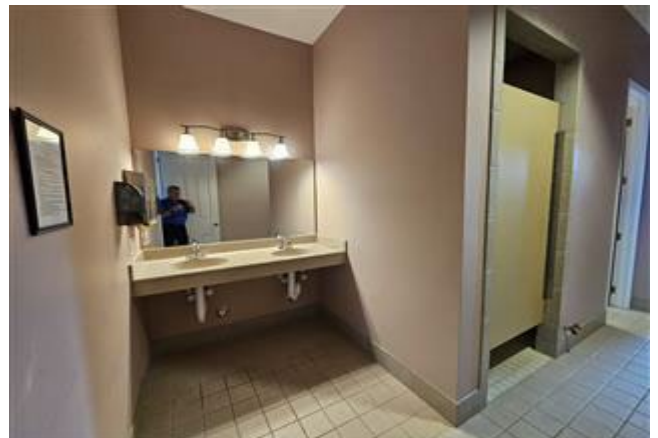
**Restrooms.** The restrooms for the clubhouse and swimming pool are located in the clubhouse. The overall condition of the restrooms appears to be good. Listed below are the major components of the restrooms:

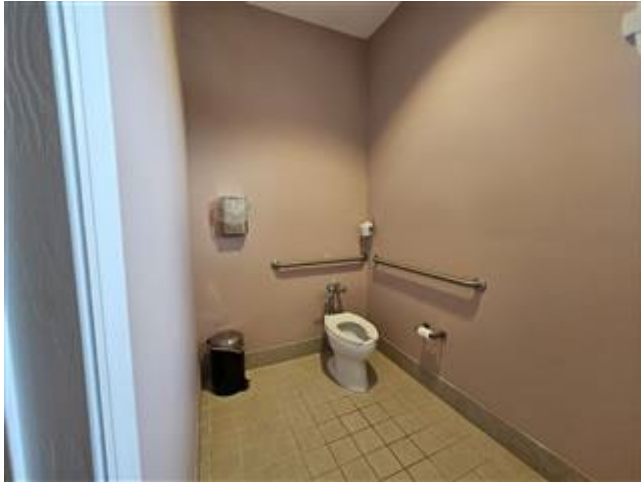
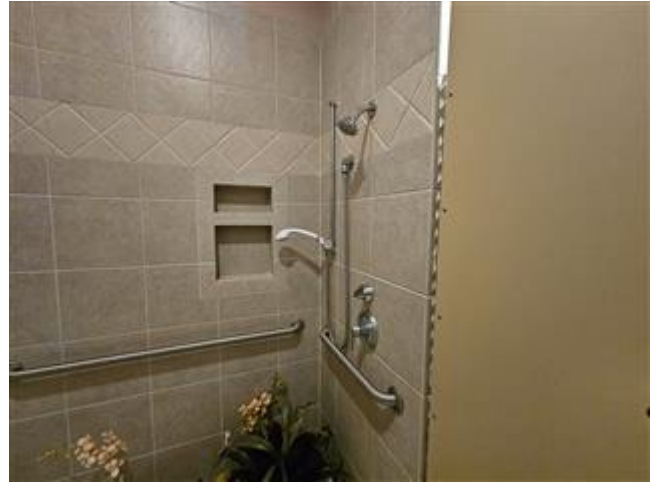
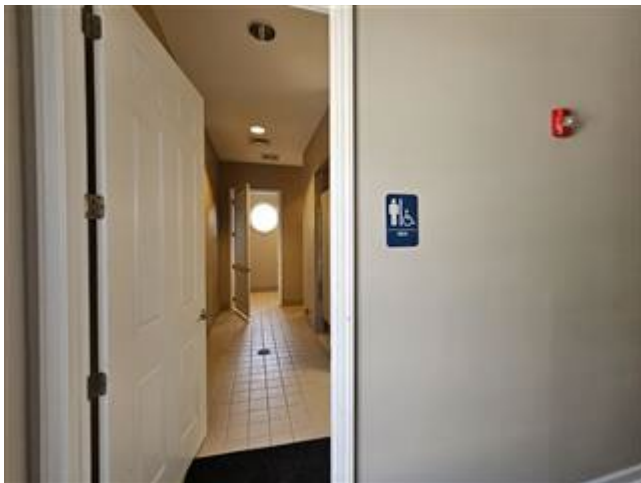
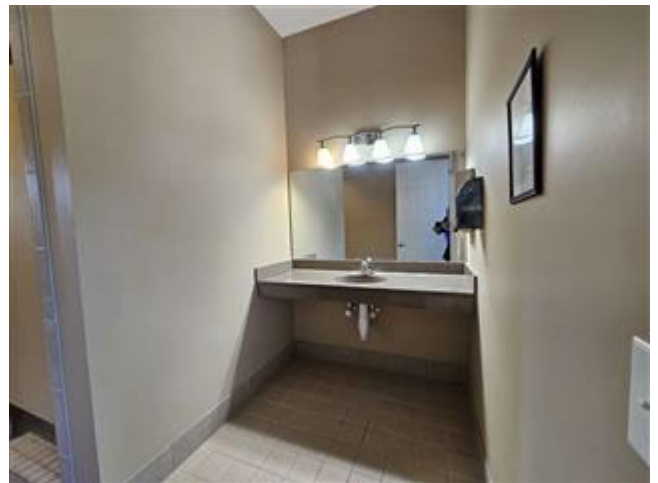
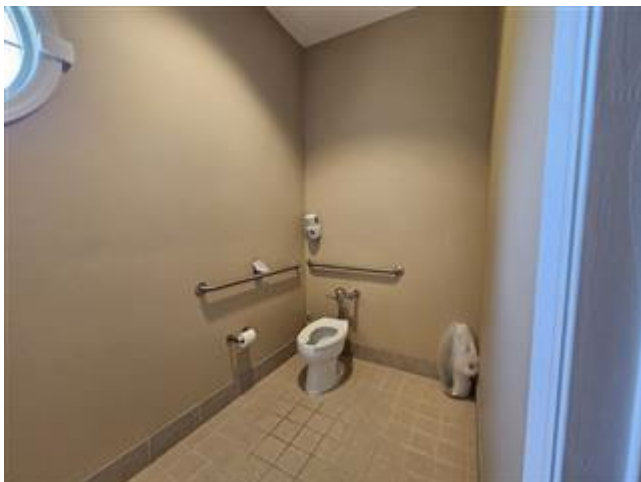
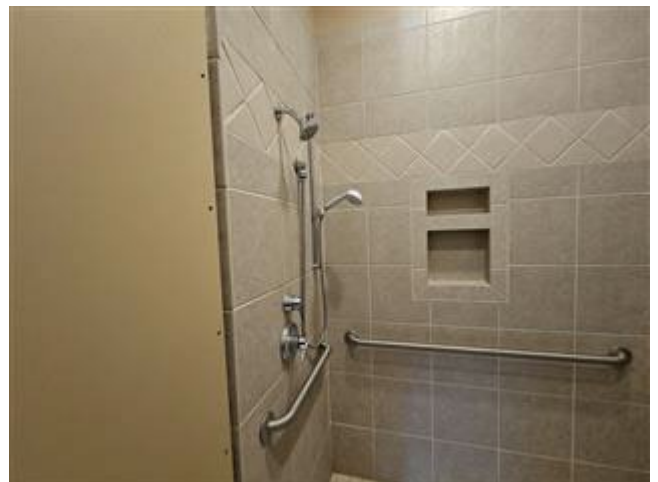
Ceramic Floor Tile. The ceramic tile in the restrooms appears to be in good condition.

Shower and Restroom Fixtures. All shower and restroom fixtures appear to be in good condition. We have assumed a service life of 12 years for the fixtures and that all fixtures will be replaced at the same time as part of a general renovation of the restroom.
